## Evaluation of a Retrofit OH-58 Pilot's Seat to Prevent Back Injury

December 1994

4. PERFORMING ORGANIZATION REPORT NUMBER(S) USAARL Report No. 95-9			5. MONITORING ORGANIZATION REPORT NUMBER(S)		
6a. NAME OF PERFORMING ORGANIZATION U.S. Army Aeromedical Research Laboratory		6b. OFFICE SYMBOL (If applicable) SGRD-UAD-IE	7a. NAME OF MONITORING ORGANIZATION U.S. Army Medical Research and Materiel Command		
6c. ADDRESS (City, State, and ZIP Code) P.O. Box 620577 Fort Rucker, AL 36362-0577			7b. ADDRESS (City, State, and ZIP Code) Fort Detrick Frederick, MD 21702-5012		
8a. NAME OF FUNDING/SPONSORING ORGANIZATION		8b. OFFICE SYMBOL (If applicable)	9. PROCUREMENT INSTRUMENT IDENTIFICATION NUMBER		
8c. ADDRESS (City, State, and ZIP Code)			10. SOURCE OF FUNDING NUMBERS		
PROGRAM ELEMENT NO.		PROJECT NO.	TASK NO.	WORK UNIT ACCESSION NO.	
62787A		30162787A878	EA	138

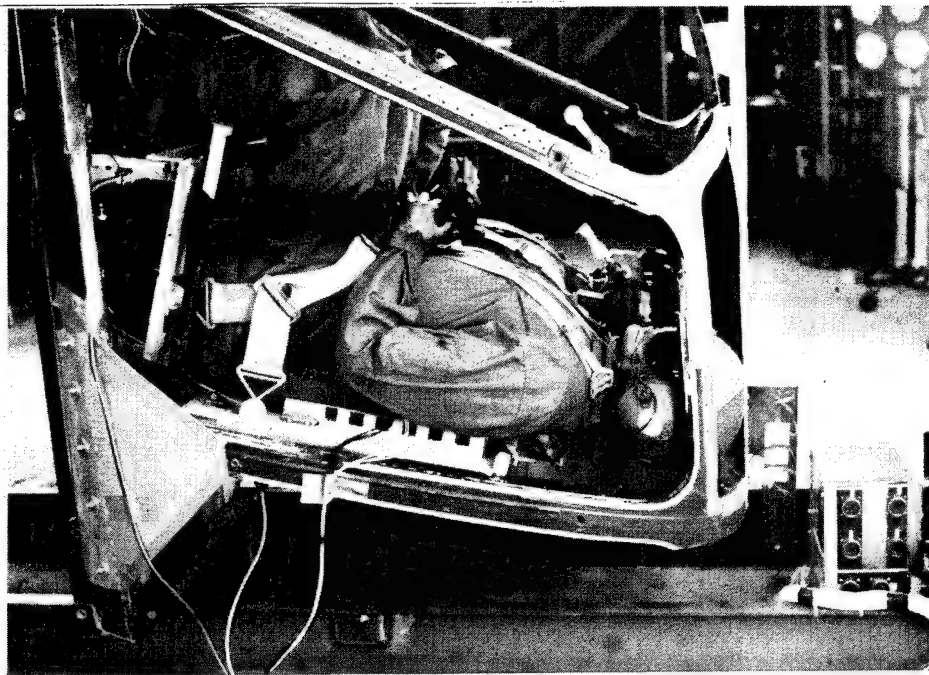
Figure 20. Posttest view of test 88058, showing 95th percentile VIP dummy (note the .05-inch thick aluminum sheet used to stabilize the floor-to-bulkhead joint, and the slack in the wire bender at point "W").

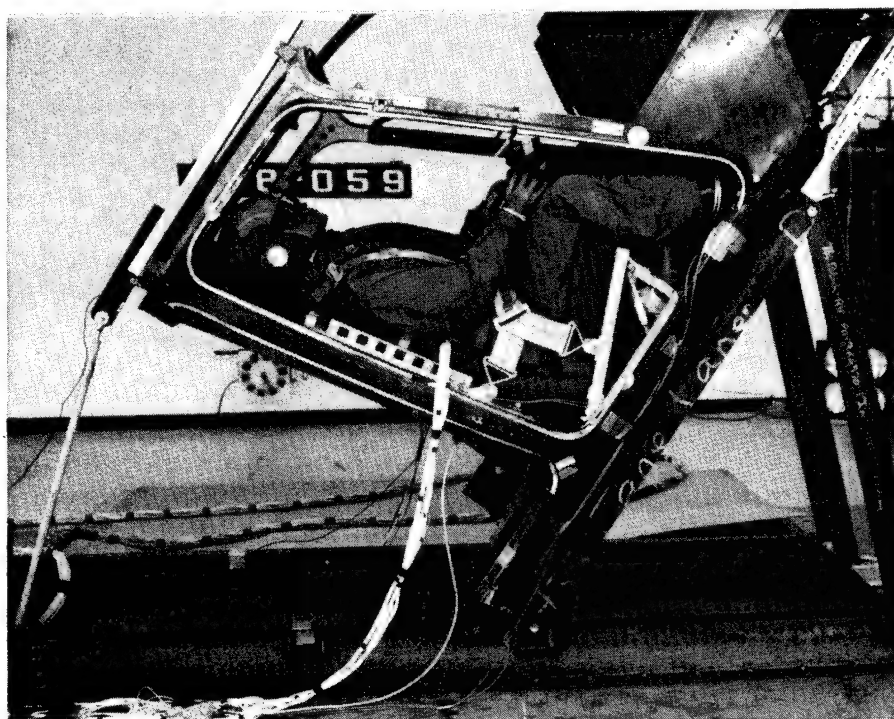
Figure 22. Posttest view of test 88059 (note slack wire bender device).

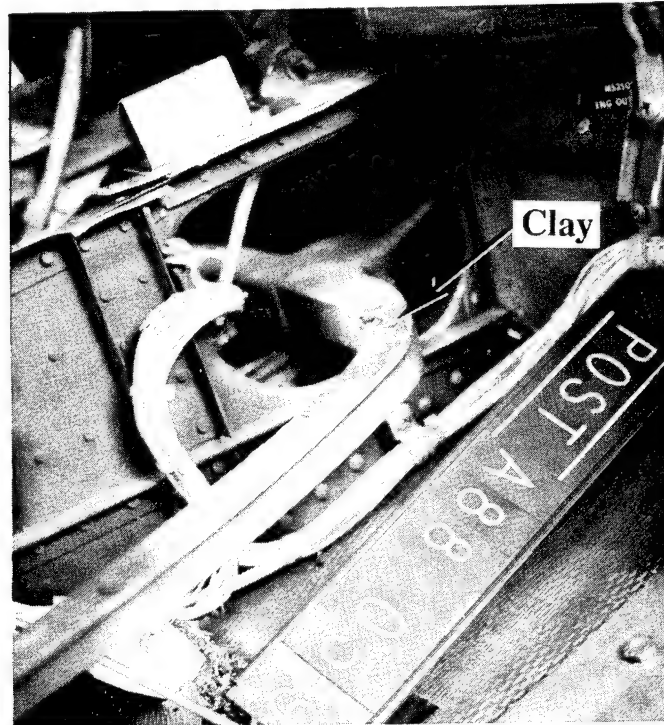
Figure 23. Modeler's clay on underfloor yoke revealing the impact point of the left armor plate (note failure of BL 5.21 brace tube anchorage).

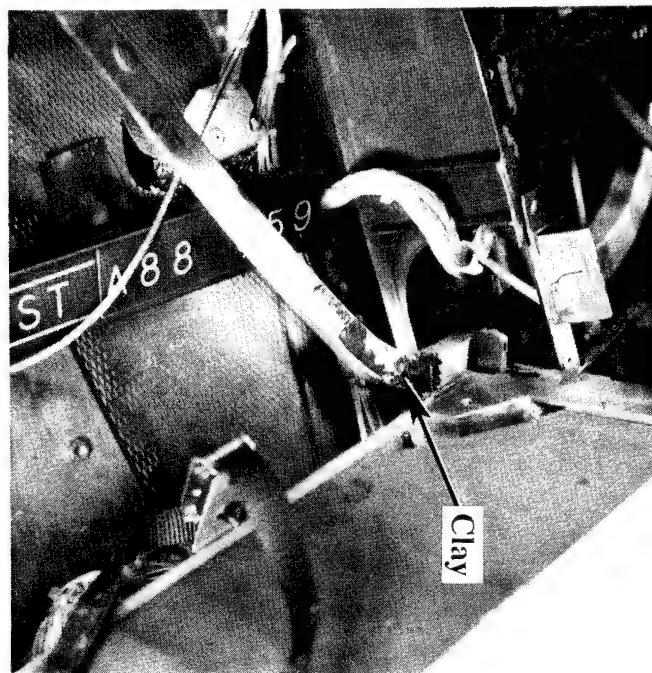
Figure 24. Underfloor yoke impact at bottom armor plate rear edge.

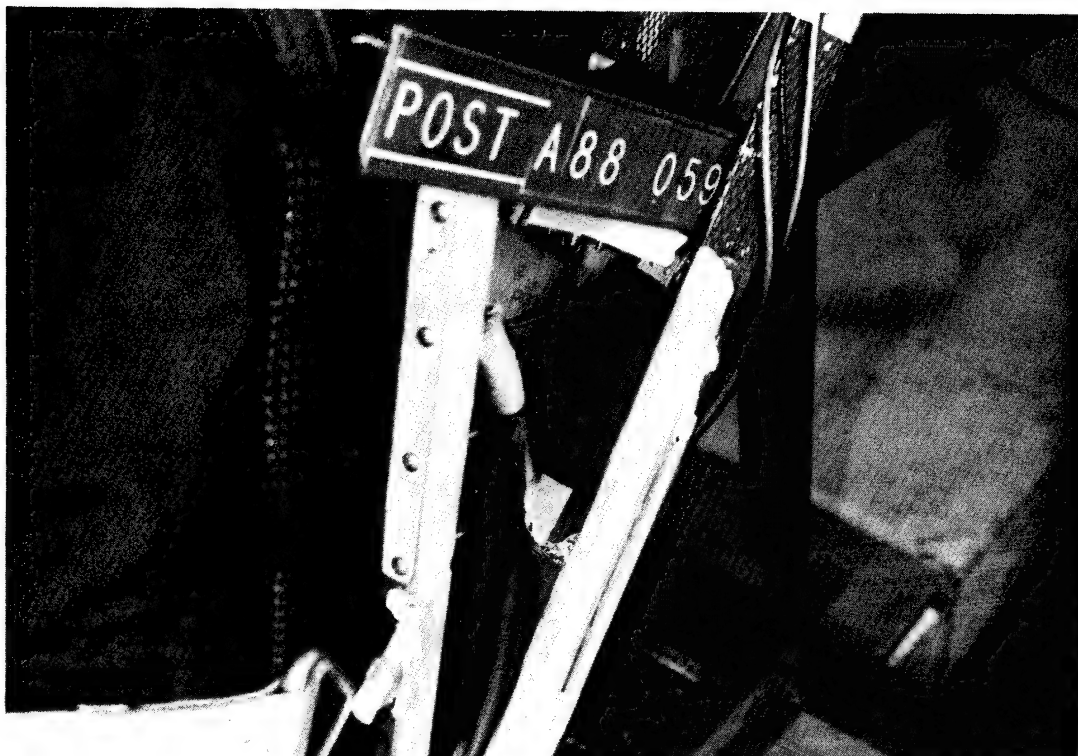
The recorded transducer traces may be reviewed at Figures A-8 through A-11. The seat leading edge bulkhead braces at BL 17.5L, 5.2L, 7.2R, and 20.3R were torn free from their anchorages to the cockpit floor. The failures of these anchorages in the honeycomb floor were photographed and are shown in Figures 23 through 29. The stresses and corresponding loads in the three tubular braces are presented in Figure 17. The brace loads in this test are compared to those from the two pure vertical tests. Note an initial compressive load, due to the downward impact, did not occur in this test, and some tensile load appeared at 34 ms about the same time that the armor plate accelerometers showed deceleration (Figure A-8). The chest X deceleration of the right dummy (Figure A-8) peaked at 24 G, reflecting dynamic overshoot from the 34 G peak sled value acting at 34 degrees from the z-axis. The chest z-value, on the other hand, peaked at only 6 G, a value apparently incompatible with the known 12 G input to the buttocks as indicated by the 1300-lb load shown in Figure A-9. The same chest z-value was correspondingly too low in Figures A-1 and A-4 for tests 88057 and 88058, respectively. The chest z accelerometer appeared to have been inadvertently plugged into the y-axis chest accelerometer. This conclusion is based on the fact that the transducer also read very low negative and positive G in later PDU tests (runs 88060, 88061, and 88062), but when the cockpit was yawed 15 degrees for tests 063 and 064, the z-axis transducer came alive and displayed values of 10 to 15 G as would be expected for the y component. Thus, the chest z values shown are assumed to be chest y values.

The failures of all four brace attachments to the "bathtub" honeycomb floor are depicted in Figures 25-29.

Figure 25. Failure of BL 20.3 right outboard brace tube anchorage to floor.

Since the anchorages did fail after sustaining this force for about 10 ms (Figure 17), we believe only a small strength increase would sustain the test loads. It is suggested the horizontal shear be carried through the honeycomb "bathtub" at the outboard edges of each seat and at the center console web. The cost and weight of a web structure should be lower than the separate bracing tubes.

#6. Delete floor-to-bulkhead braces at BL 17.5L, 5.2L, 7.2R, and 20.3R and replace with horizontal beam between knee bulkhead and FS 73.06 canted bulkhead.	-2.0 (approximately)

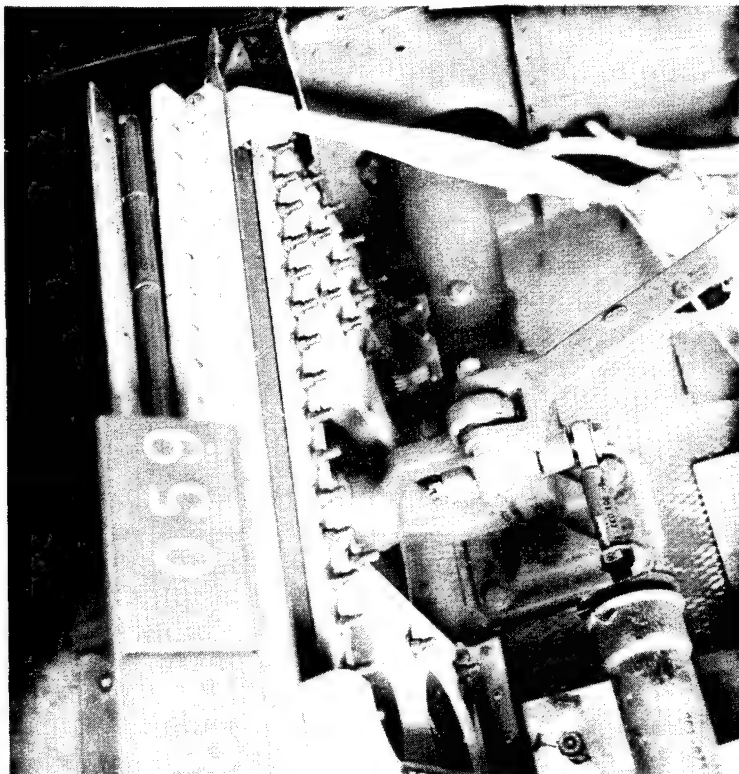
Figure 26. Postmortem view of BL 17.5 left brace and BL 5.2 left brace tube (note slight separation of MS35830 hinge at inboard edge).

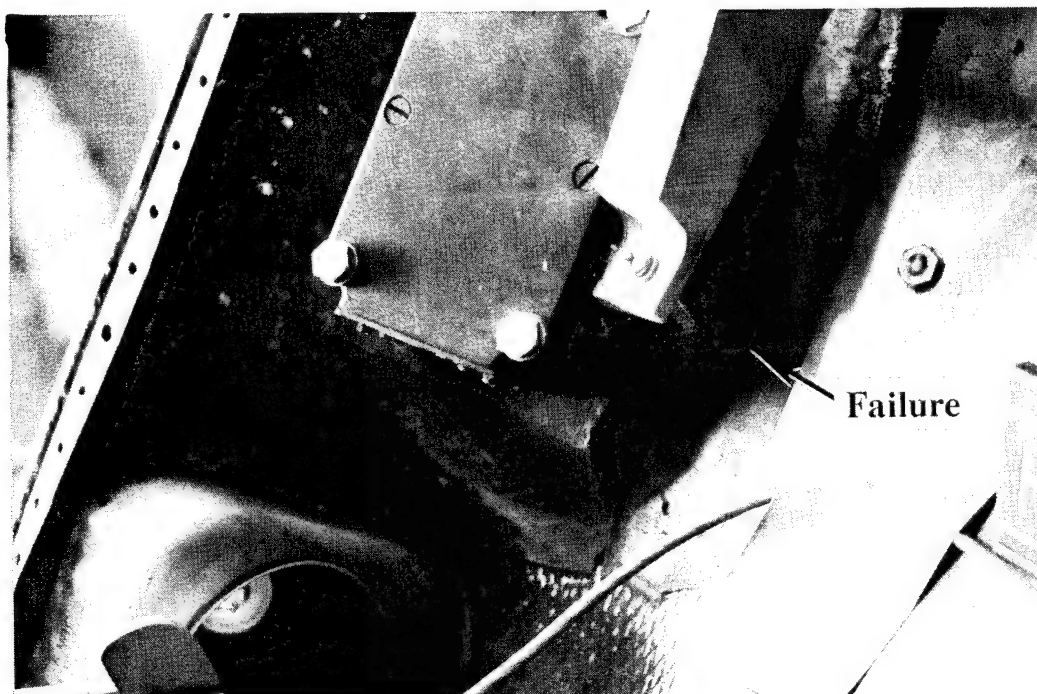
Figure 27. Failure of BL 17.5 left brace anchorage to floor.

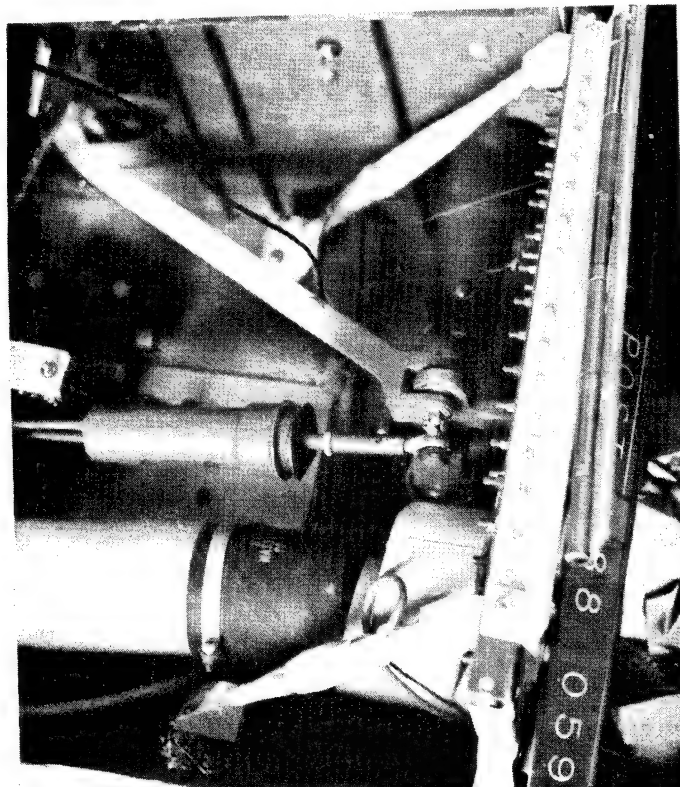
Figure 28. View of right seat area after removal of armor plate at hinge (note separation of M535830 at bottom of photograph).

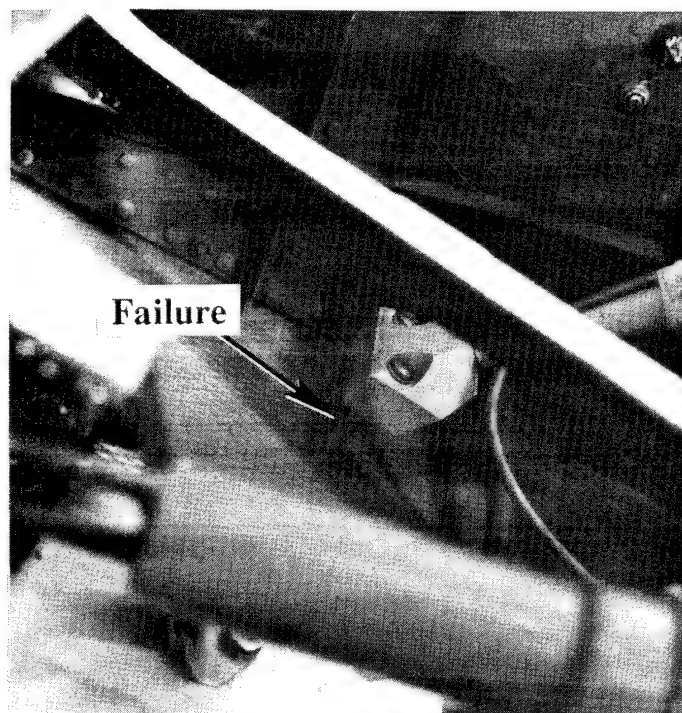
The failure of all four brace anchorages at a horizontal velocity change of only 18 fps and approximately 20 G impact is a point worthy of redesign effort for a production seat. The right inboard (BL 7.2R) anchorage failed at only 1373 lb, little more than half the failure load of the other two tubes at 2203 lb  $((2222+2184)/2)$ . If failure had not occurred in the right inboard brace, and 2203 lb were sustained in each brace, the horizontal x-axis load would be as follows:

Figure 29. Closeup view of BL 7.2 right anchorage failure at 1373 lb.

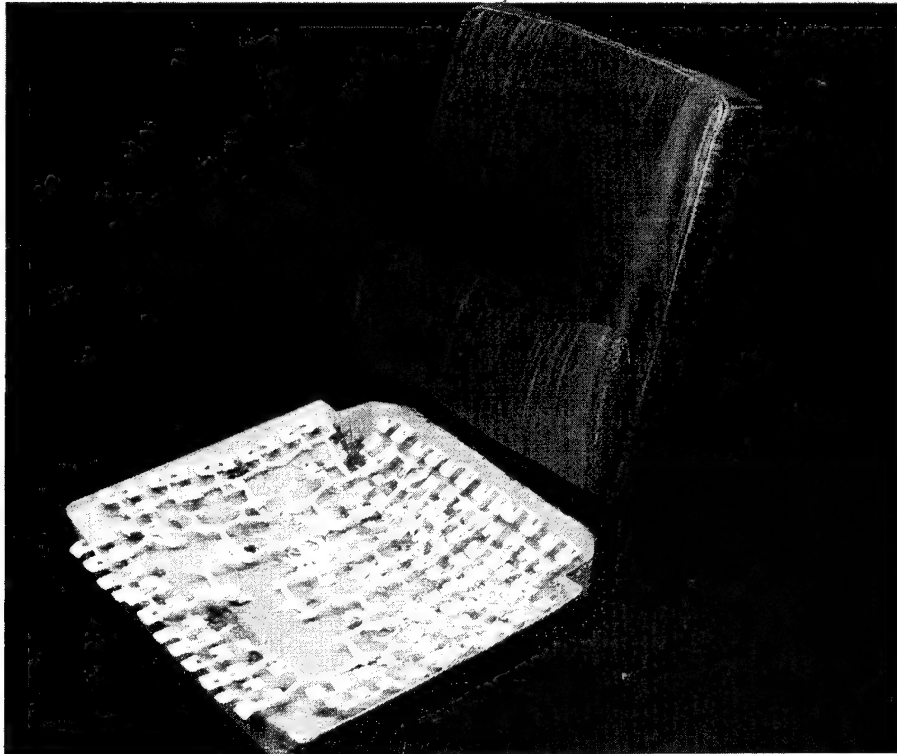
The degraded PREQUAL™ was replaced with foam cushions (cut to size) from wrecked UH-60 seats, and the frayed, worn SPACEFABRIC™ was replaced with black sheepskin covers, also from UH-60 wrecked seats. A recent inspection reveals the seat cushions are still serviceable, but the sheepskin is faded somewhat after 4 years exposure in the JOH-58A. Unless SPACEFABRIC™'s resistance to sunlight is improved, the sheepskin material appears to be a viable candidate to replace it.

Figure 36a. Copilot seat bottom and back cushions after removal of PREQUAL™ cover after 20 months and 100 flight hours in JOH-58A (Ser 71-20778).

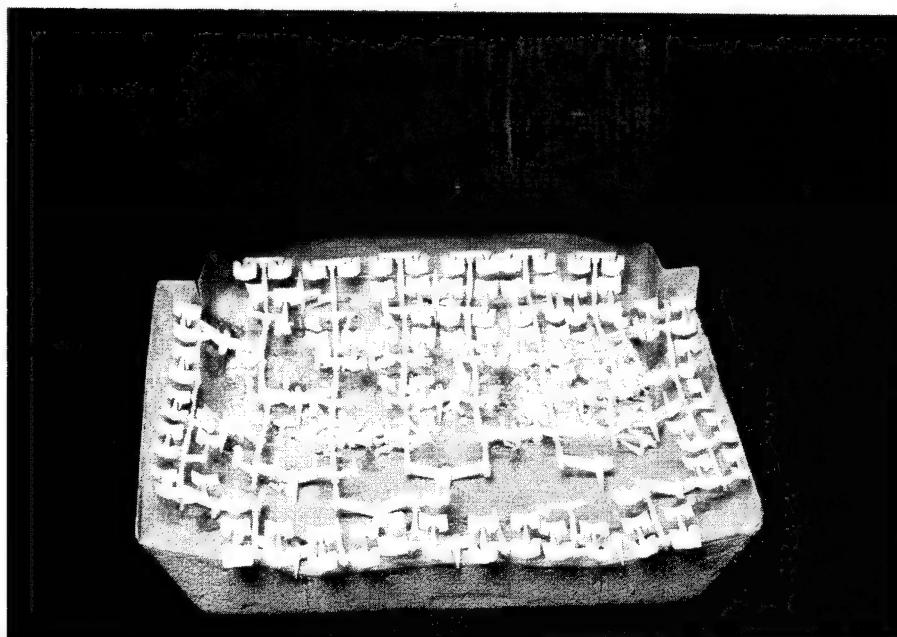
Figure 36b. Copilot (left) seat bottom and back cushions (note disintegrated plastic lever supports).
